**SAS Superstructure**

Location: 04-SF-80-13.2 / 13.9

Daily Diary Report by Bid Item

Diary #: 078 Const Calendar Day: 287 Date: 22-Jun-2010 Tuesday

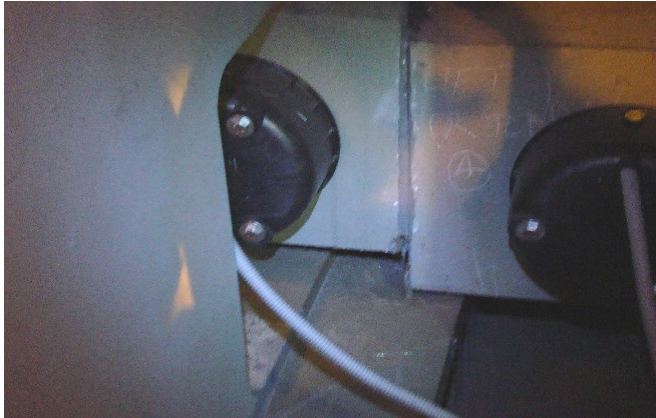
The grout temperature at 9:22am was up to 86F using the infrared temperature gun. All other temperatures were taken with the thermometer. At 9:45am it was discovered that continuity tendons E27B, E28B, and E29B had "major leaks" at the dead end bearing plate and pipe joint. The bottom row which consist of tendons E15B to E29B were abandoned because it was discovered that ABF laborers didn't seal the voids at the dead end joint. SDI ironworkers proceeded to grout tendons E14B towards 1B. SDI ironworkers also began to blowout the fluid grout placed in tendon E29B using the air compressor from the dead end.

Leaking grout observed at the dead end bearing plate to pipe joint for E27B.

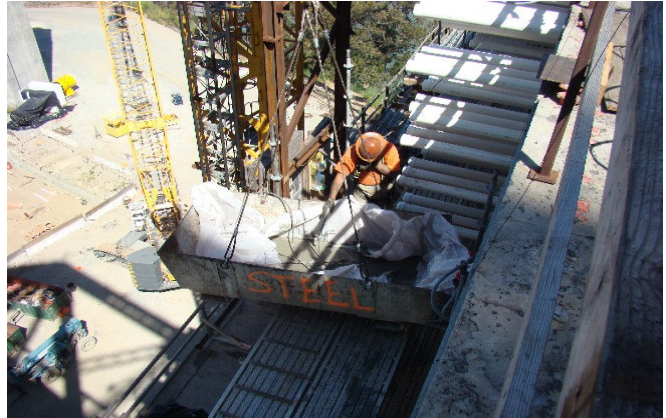
At 10:54am the temperature of the grout was 90F, efflux time was measured at 20 seconds, and the S.G. was 2.08 (129.8pcf). The grout placed in tendons E27B and E29B was flushed out of the ducts at the time of testing. ABF laborers managed to seal the the dead end joint of tendon E28B and the SDI ironworkers recharged this tendon. At 1:03pm the temperature of the grout was 81F, and the ambient temperature was 56F at this time. The grouting operation was completed at 1:34pm. The continuity tendons grouted today along the E-Line were 1A to 16A, 1B to 14B, 28B, 30B to 40B, 42B, E43, and E44 for a total of 45 done today. Overall the grout appeared to look acceptable and was mixed consistently.

Discharging the grout for E29B since there was a leak at the dead end.

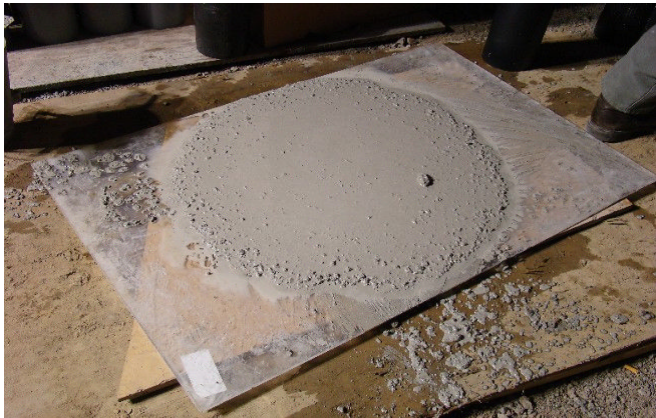
Slump flow taken from the second truck, VSI rating was a 2 for this SCC patty.

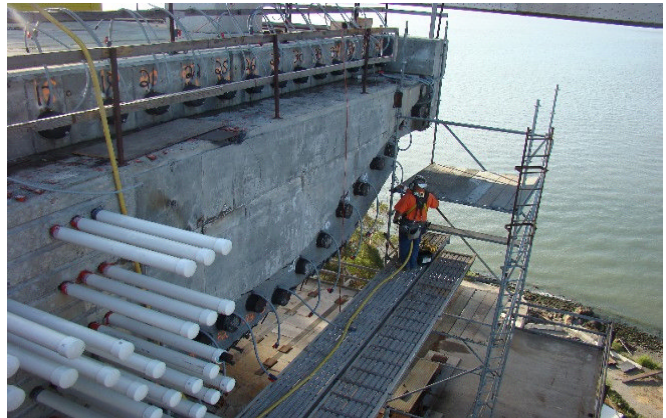
SDI ironworkers pumping grout into the E-Line continuity tendons from the live end (westside of W2 cap beam)

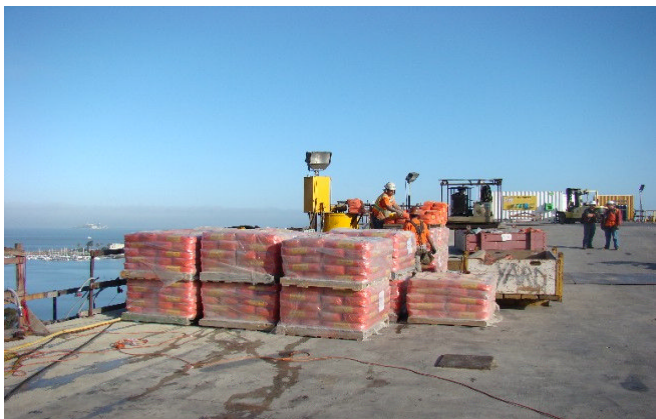
Grouting pump and pallets were positioned on top of the W2 cap beam
